Marine Tests - Italy 2002

Executive Summary

DSE Tests were conducted aboard the Carnival

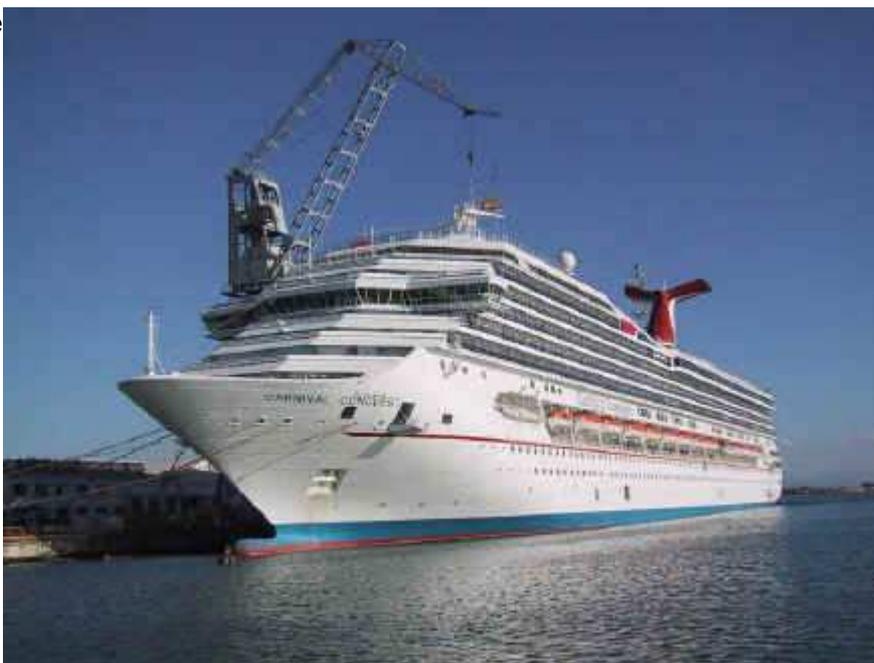
The 9 deck atrium was filled with theatrical smoke and equipped with DSE sounders on all 26 exits, 20 of which were on the lower three decks – this created a potentially confusing acoustic environment. Participants were lead into the centre of the lowest deck to points of maximum acoustic confusion (from which no illuminated exit signs were visible but the sounds from many sounders were audible). They were asked to find exit doors – which they readily and quickly achieved, some then walked around the three lower decks of the atrium, locating door after door. Many remarked on the precision with which sounders could be located.

Since the vessel was in the course of handover, its decorative finishes were complete. To avoid damage to decor some of the DSE sounders were located adjacent to exit doors rather than vertically above the door handles.

There were several comments on the extreme precision with which the DSE sounders could be located. Since many of the sounders had been located to one side of the door (to avoid damage to décor in this test), several participants found themselves directly in front of a sounder but actually at the side of a door and thus unable to locate a door handle nearby.

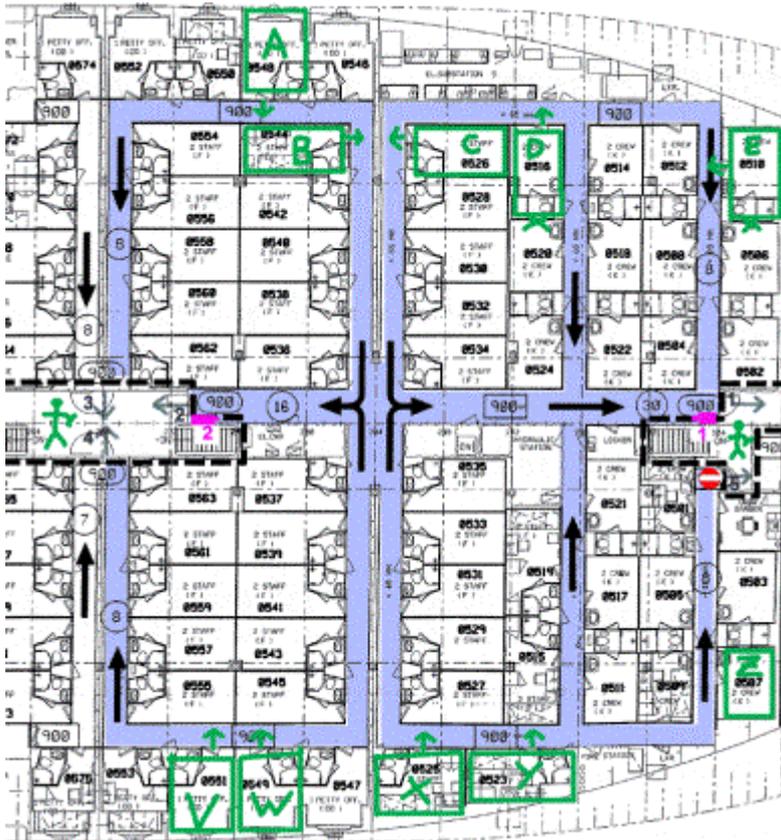
and confuse them. No layout plans were on the backs of the cabin doors, cabin door numbers were obscured and participants were lead through smoke filled corridors to a series of cabins situated in confusing locations (each with several possible choices of evacuation route). They waited whilst the corridors were completely filled with dense theatrical smoke simulating loss of vision caused by the attack of real smoke on the eyes (visibility about 0.5-1m). On PA announcement – they were asked to find their way out. After a short time – 30 seconds in the LLL test and 15 second in the DSE test, the GA alarms were started and ran to the end of the tests. In the DSE test, there was a PA announcement during the test to evaluate audibility.

In the first test the participants had the benefit of LLL. In the second test, the same people were guided to different cabins and asked to repeat the exercise this time using DSE for guidance (the LLL was switched off). Each participant had numbered vests and was observed using thermal imaging cameras. Observers at each exit logged their exit times. On completion of the tests, each participant completed a questionnaire to log their experiences.

The test area had five possible exits – two forward, three aft. One of the forward exits was blocked by a security guard simulating the exit being blocked by a fire. When participants arrived at that exit, they were instructed to find an alternative. This was to test the ability of LLL and DSE to trace back their route and find alternative exits.
